## 2022 Halls Gap Fire Plug Audit

**Author:** Halls Gap Resilience Group  
A sub-committee of the Community Association of Halls Gap Inc.

**Date:** September 2022

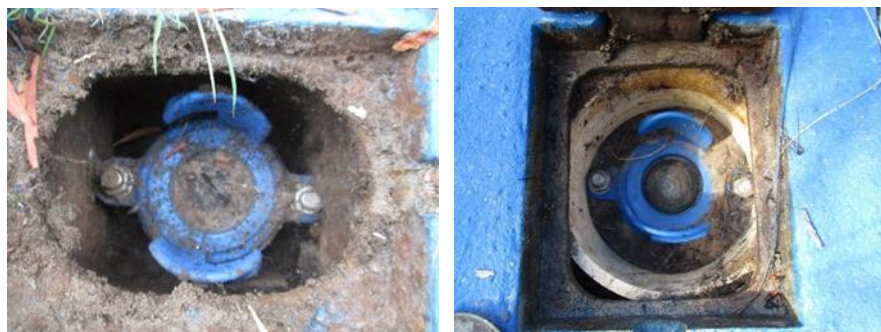
**Figure 1: Relatively New FPs**

Some relatively new FPs were observed in the newer housing developments, and some others were presumably replacements for failed FPs (see examples in Figure 1), but the earliest part of the FP network is over 40 years old, and most of these fittings are exhibiting corrosion, including around the plug valve (see Figure 2.) The corrosion is probably not serious enough to affect the use of the FPs yet, but this should be confirmed by inserting a portable hydrant and slowly opening and slowly closing the valve (to avoid water hammer.)

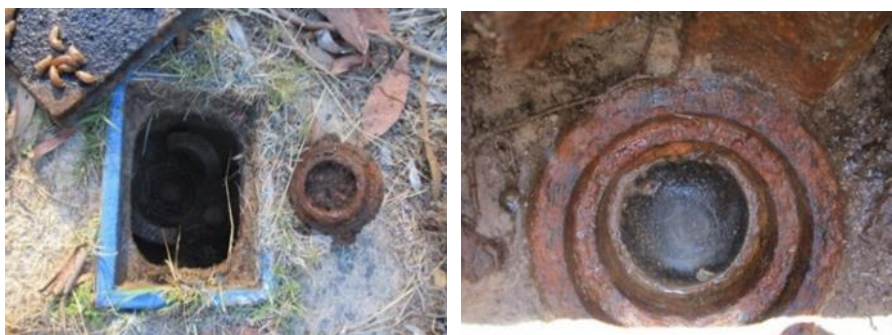
**Figure 2: Example of FP Corrosion**

- Of the dust caps present, 73% were corroded as were the valves themselves (see 2.2.)
- With three exceptions, all FPs had the required marker post (typically within 1 metre.)

1. That the NGSC allocate funding and establish a project to refurbish the network i.e. to
  - clean the silt out of FP housings,
  - replace missing dust caps,
  - treat corrosion, and repaint valves to prevent future corrosion,
  - slowly open and slowly close each fireplug valve to see if it works,
  - engage GWMWater to fix any faults in the pipework or valves,
  - clear vegetation from around the FPs,
  - install secondary marker posts (or in some cases primary posts) where needed,
  - fix defects in marker posts and blue reflectors, or replace posts with steel/concrete,
  - replace defective road markers, and install missing road markers, etc.

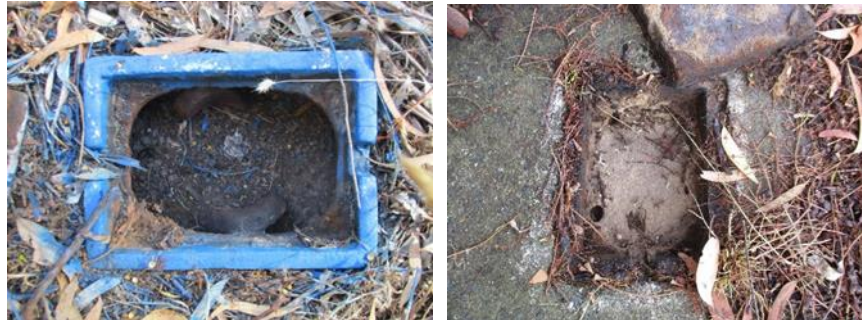
**Figure 4: Examples of Silted Up FPs**

- 60% of the FPs were silted up, some partially and some completely (see Figure 4.). Damp silt may have encouraged the corrosion affecting most of the network (see 2.2.) Some FPs were infested with ants, some with painful bites. Cleaning the plug out could delay fire fighters attempting to use it by up to 10 minutes, which could be crucial.

At the time of the audit, the FP network, including the marker posts and road markers, was in generally poor condition. It did not appear to have been inspected for a long period. The major defect was the silting up of the FP housings, which makes the FPs unusable until the silt is removed. Once the silt is removed, the network was probably still functional in all cases, although corrosion was a concern. (Careful testing was recommended to confirm network functionality.)

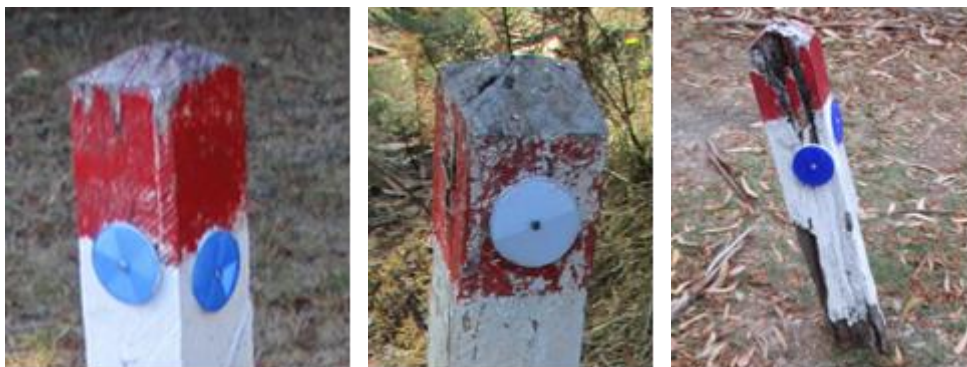
**Figure 5: Worn or Flaking Red Paint on Marker Posts, Rotted Posts**

- 63% of the marker posts had worn or flaking red paint on their tops (see below.) With inadequate paint protection, some of the tops are rotting. Some bases are rotted also. Marker posts in bushfire-prone areas should be non-combustible (steel or concrete.)

- 78% of marker posts had the correct blue reflectors. The rest had either one missing or a broken reflector. The colour had faded in some reflectors (see example above.)
- Only 58% of the FPs had road markers (or 'cats eyes'.) The reason for the lack of a marker in 45% of the missing cases was that the roads were unsealed i.e. there was no stable surface to fix the road marker to. However in the remaining 55% of cases of missing road markers (32 FPs) they should have been in place.

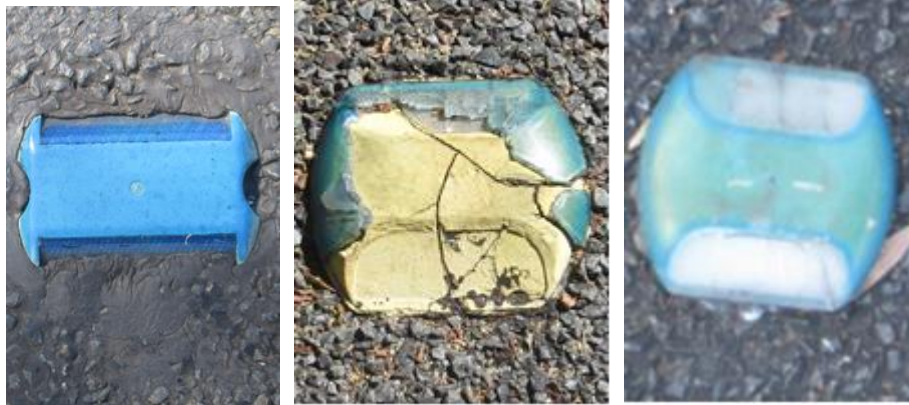
**Figure 6: Example of Defective Road Markers**

- 68% of the road markers did not comply with the CFA's *Identification of Street Hydrants for Firefighting Purposes* in that they were installed at the side of the road instead of close to the centre (but this probably isn't serious enough to require rectification.)
- 20% of the road markers were either partially buried in asphalt, damaged, or had lost their blue reflectivity (see examples below.)
