# Halls Gap Threat & Risk Assessment

Author:	Halls Gap Resilience Group A sub-committee of the Community Association of Halls Gap
Contact	secretary@resiliencegroup.org.au
Version:	2.4
Date:	February 2024

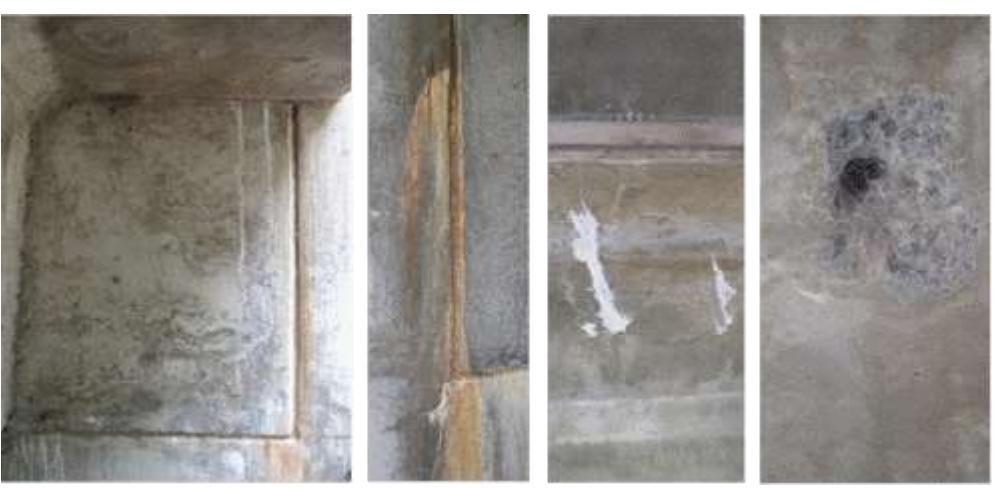
#### Figure 56: Delleys Bridge Defects

Delleys Bridge does not appear to have a VicRoads condition rating. A physical inspection identified some very minor cracking, efflorescence and spalling (Figure 56) but no serious issues. The threat likelihood of failure is assessed as Rare.

Cracking and efflorescence

Spalling

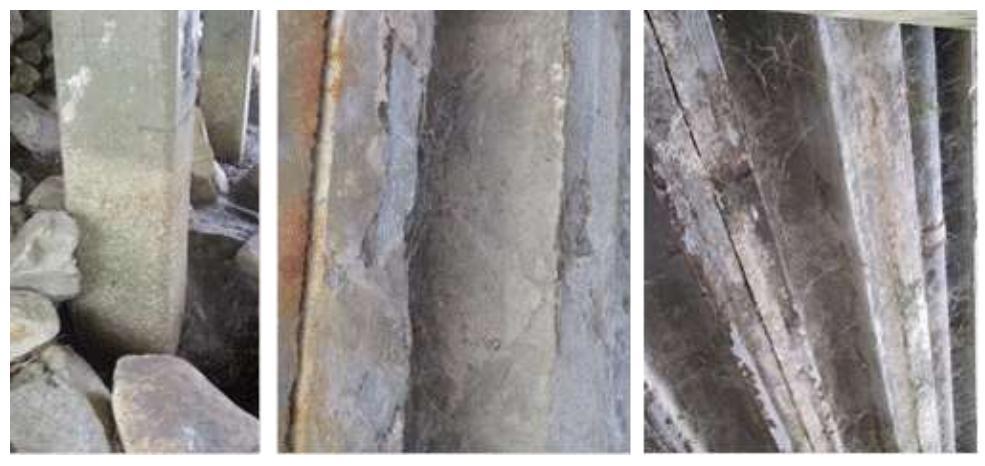
#### Figure 57: Grampians Road Stony Creek Bridge Defects

VicRoads rates bridges according to their condition. In general, bridges that are free of defects affecting structural performance, integrity and durability will have a condition rating of <30. Structures with a rating of 30 to 60 are deemed to have defects that could affect serviceability/durability. The Grampians Road Stony Creek Bridge has a rating of 29, which is marginal. A physical inspection identified problems of waterwash, spalling, cracking and efflorescence (Figure 57.)

Spalling

Cracking and efflorescence

The bridge is believed to have been built in 1956 so has existed for 65 years, but ongoing deterioration of its condition may affect the future likelihood of failure. Transport loads have increased since it was built (e.g. truck rear axle loads can now be as high as 22.5 tonnes.) The condition of the Stony Creek bridge was referred to VicRoads. In response the Department of Transport stated they perform a Level 1 inspection of the bridge every 6 months, and they are comfortable that it is currently structurally sound and not a concern. The threat likelihood is rated as Rare.

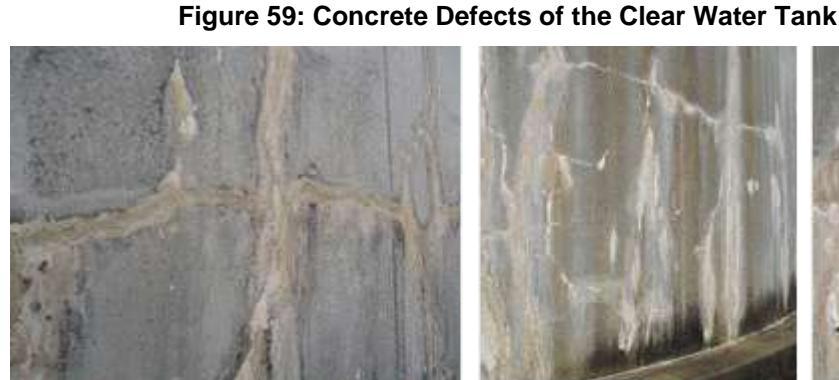
TRILITY has advised that the clear water storage is routinely inspected (6 monthly) externally as part of its on-going maintenance schedule. The tank has an internal membrane that ensures no leaking can occur, minimizing the risks of loss of supply. Any staining or corrosion is from weather conditions on the outside of the tank.

Repaired cracks
