## 2022 Halls Gap Fire Plug Audit

**Author:** Halls Gap Resilience Group  
A sub-committee of the Community Association of Halls Gap Inc.

**Date:** September 2022

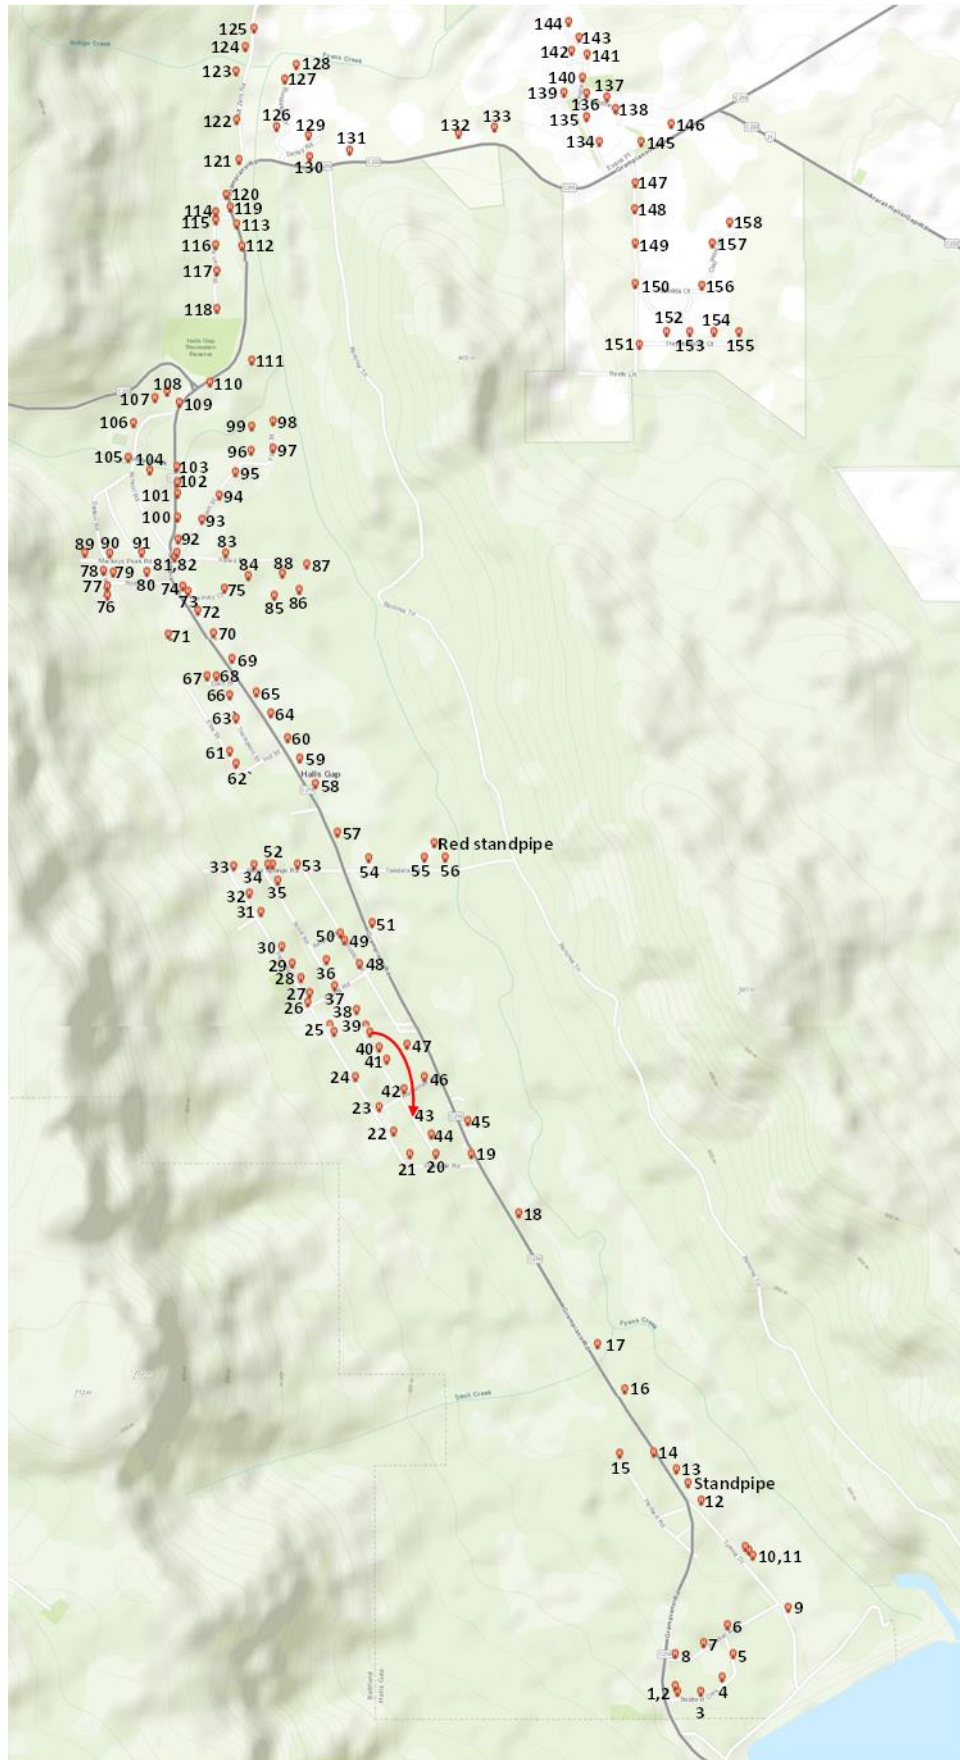
Figure 3: Map of FP Network

The audit was completed by physically identifying each FP, using the map shown in Figure 3. Individual FPs were allocated numbers for identification, and these numbers were added to the map. In some cases, there were problems with locating the FPs. For example:

- FP 12 could not be located. The marker post was present, but the plug itself was not evident, and may be under the adjacent path, which has recently been re-surfaced. Similarly FPs could not be found for three other marker posts (probably buried nearby.)
- One of the plugs on Scott Road is shown in the wrong place (see red arrow on map.)
- Five of the FPs appeared to actually be water valves, although in one case a buried FP was later discovered close by, so it is possible FPs are present in the other cases.
- Overall, 18 (11%) of the FPs marked on the map could not be easily located.
