# Halls Gap Threat & Risk Assessment

Author:	Halls Gap Resilience Group A sub-committee of the Community Association of Halls Gap
Contact	secretary@resiliencegroup.org.au
Version:	2.4
Date:	February 2024

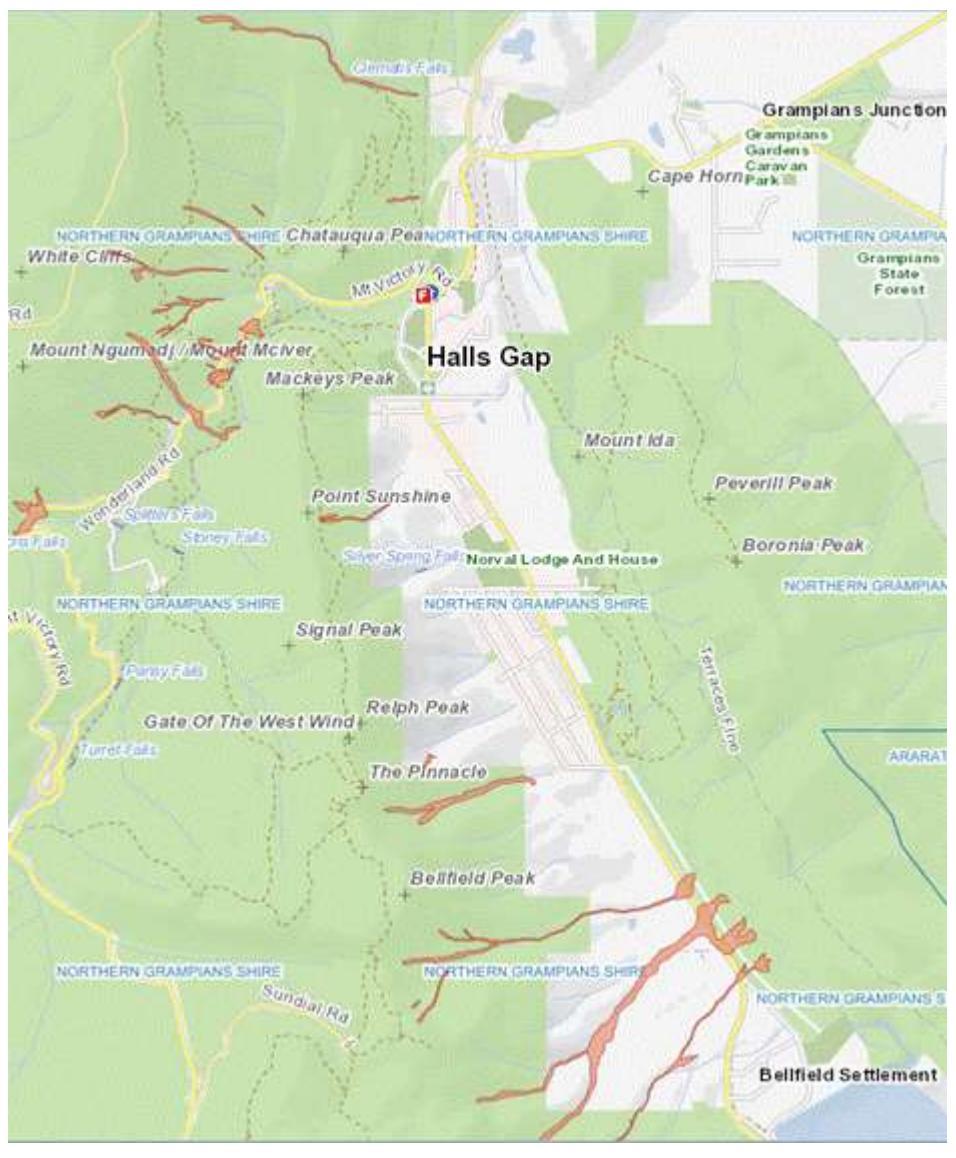
Figure 46: Impact of 2011 Landslides

In 2011, after 280 mm of rain had fallen in three days, about 170-190 landslips were identified in the Grampians National Park. The longest was almost three kilometres, the widest, about 200 metres. As shown in Figure 46, landslides adversely impacted Grampians Road.

The consequence of the 2011 landslides was severely restricted access to some areas. While mud and rocks affected private land, only three homes and two cars were reportedly damaged. No lives were lost. Some businesses were negatively financially impacted. The threat consequence is therefore assessed as Moderate.

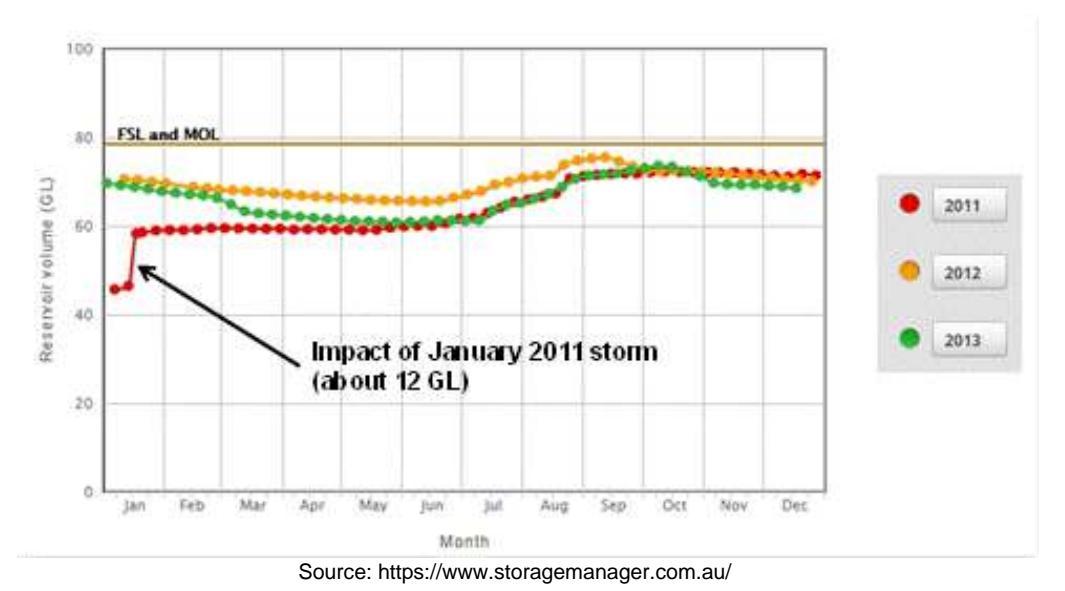
#### Figure 48: Impact of 2011 Storm on Lake Bellfield Levels

If Lake Bellfield had been closer to its Maximum Operating Level (e.g. as occurred in January 2012 and 2013) the 2011 storm would have caused the spillway lip to be overtopped (see Figure 48), resulting in significant uncontrolled water flows into the valley i.e. the flood hazard would have been much worse. Coordination of any cone valve water release aimed at preventing spillway flows would be crucial for flood control, as demonstrated by the problems with the Wivenhoe dam in Queensland<sup>9</sup>.

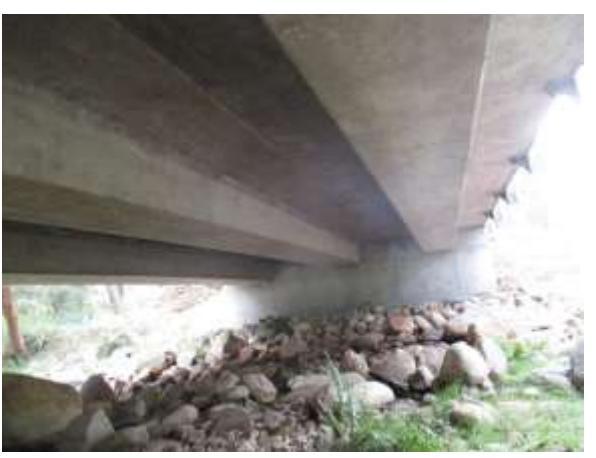
Figure 58: School Road Stony Creek Bridge

Given the low height of the bridge (about 3m) and the fact that it is in a 40km/hr speed zone, a catastrophic failure of the bridge when traffic was passing over it is assumed to lead to serious injury but not death. Alternative access is available using the Grampians Road Bridge. The threat consequence is Moderate.

The resulting risk rating is Low.

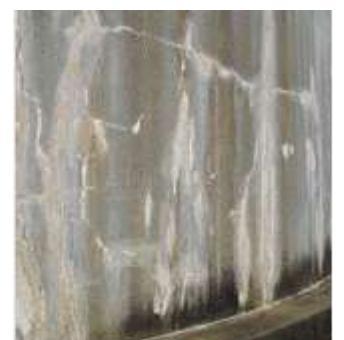
Unrepaired cracks, efflorescence
